## TCON Troubleshooting

CTV70042910

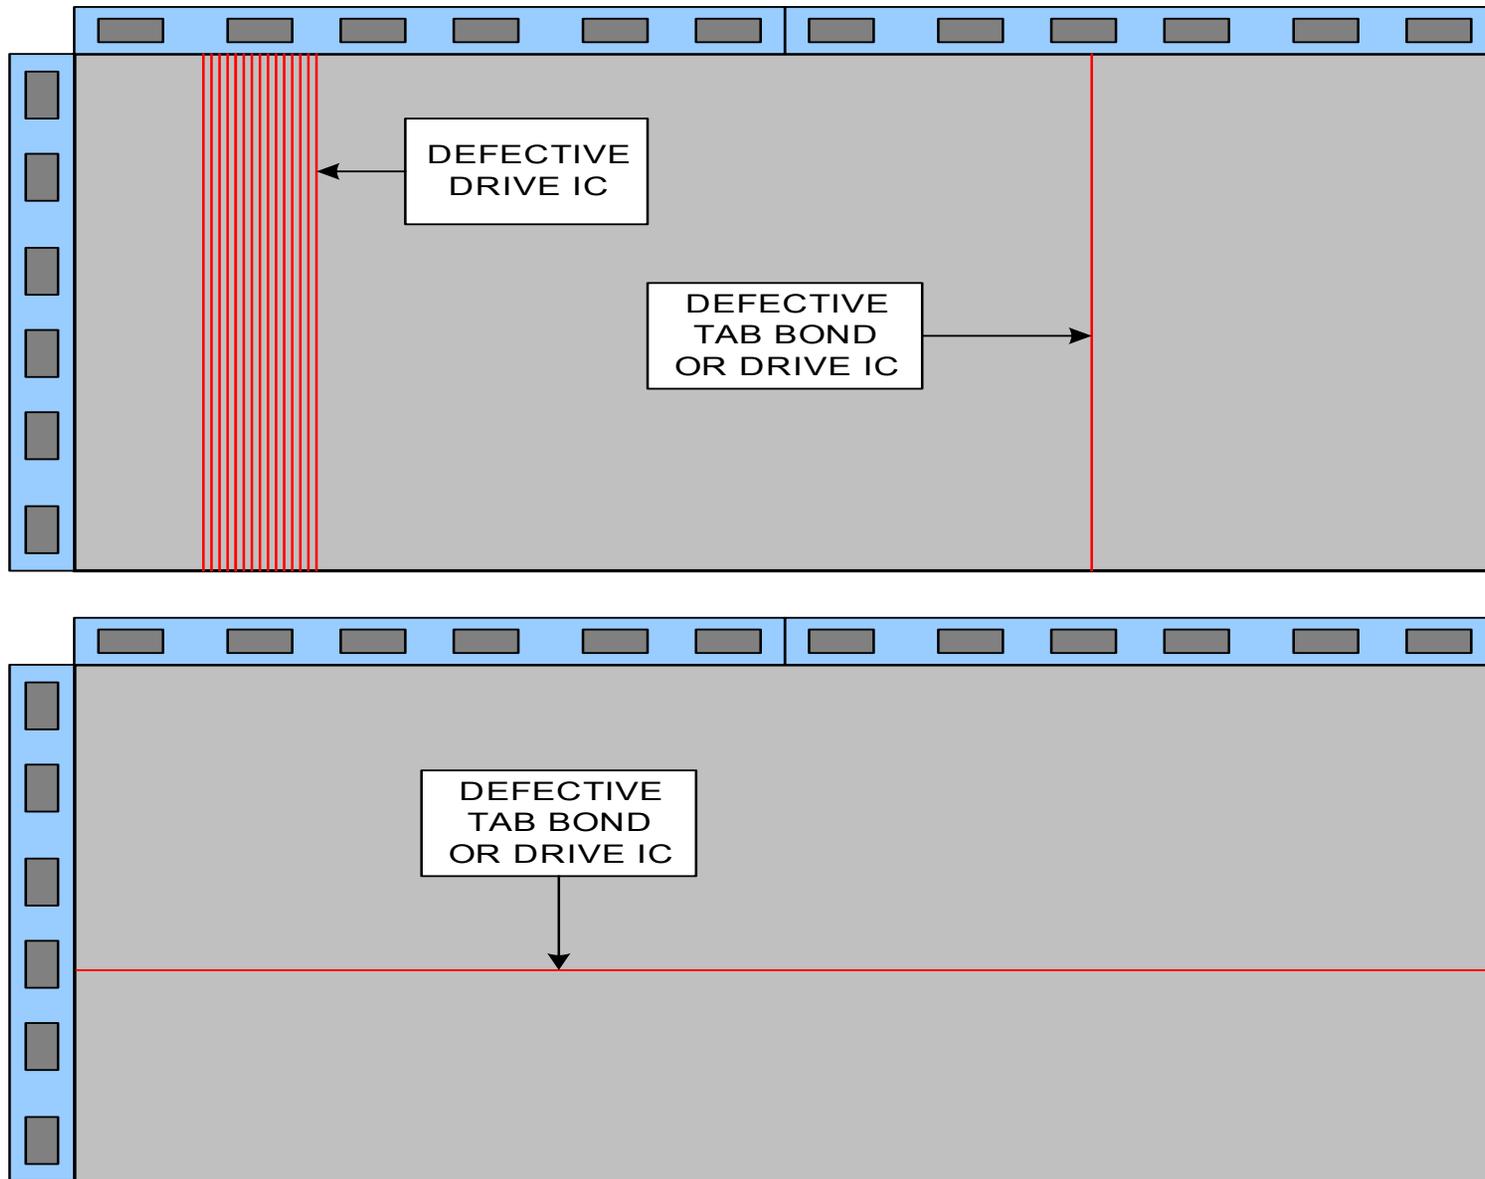
FIGURE 4-6  
TYPICAL LCD PANEL FAILURES

Failures involving the LCD panel are usually displayed with the following symptoms:

- Physical damage such as cracks in the panel, a single pixel or group of pixels that always on or off, or random sections of the panel which are completely dark.

- Source driver failure. This symptom appears as a single vertical band around 1 to 2 inches (depending on the panel size) and can be black, white, or any other color. It can also contain video information with distortion. A single vertical line that is dark or colored. This may be due to a tab bonding failure from the IC to the panel but either cause requires the replacement of the panel.

- Gate driver failure. These IC's operate in a "bucket brigade" fashion. As mentioned earlier, the gates drivers scan each horizontal line starting at the top. If any one of the gate drivers fails, all of the subsequent drivers below it will fail to operate properly. This symptom is usually indicated by normal video on the upper portion of the screen followed by distorted video from the point of the failed IC and downward.

- Any horizontal lines. The gate drivers are activated by a single source of timing information so any single horizontal line or groups or random horizontal lines are caused by an output failure from a gate driver or a loss of the tab bond to the panel.

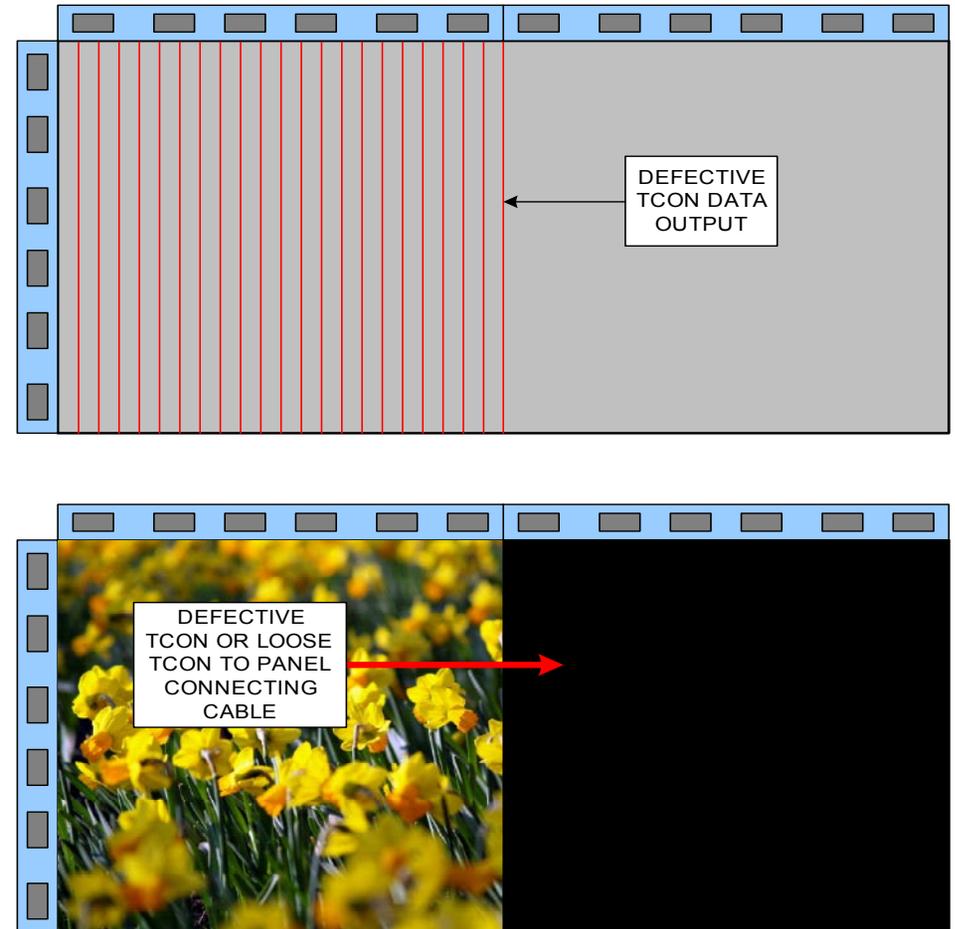
Figure 4-7 illustrates 2 examples of a loss of control data to the drive IC's. In the first example, an entire group of column drivers has lost the data stream for red. The second example involves the complete loss of drive data for all RGB information to the right side of the screen. This is sometimes caused by the flat cable connecting the TCON to the LCD panel coming loose. The area of missing video can be dark or completely white depending on the panel design.

FIGURE 4-7  
LCD TIMING CONTROL FAILURES

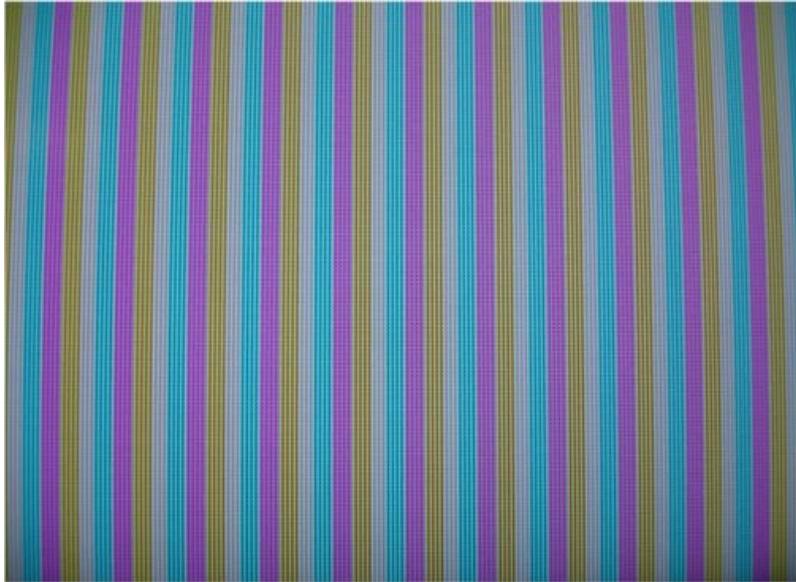
REPETATIVE STAIONARY LINES

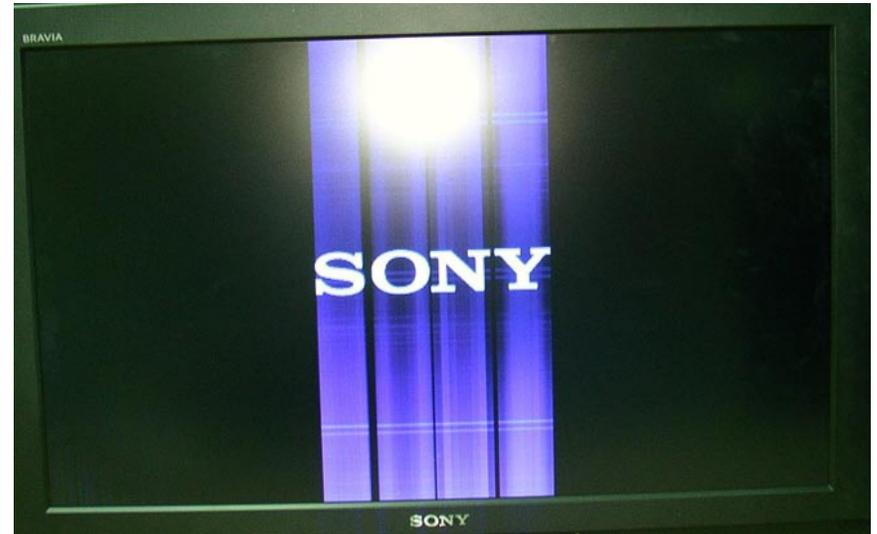
MULTIPLE SOURCE DRIVE IC FAILURE

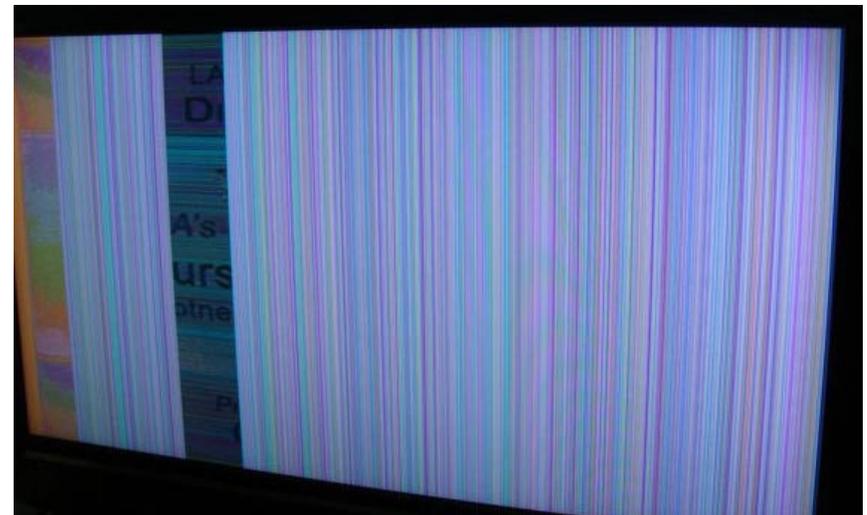
MULTI-COLORED LINES. NOTE THE PRESENCE OF SOME ACTIVE VIDEO INDICATING THE VIDEO PROCESSOR IS NOT THE CAUSE

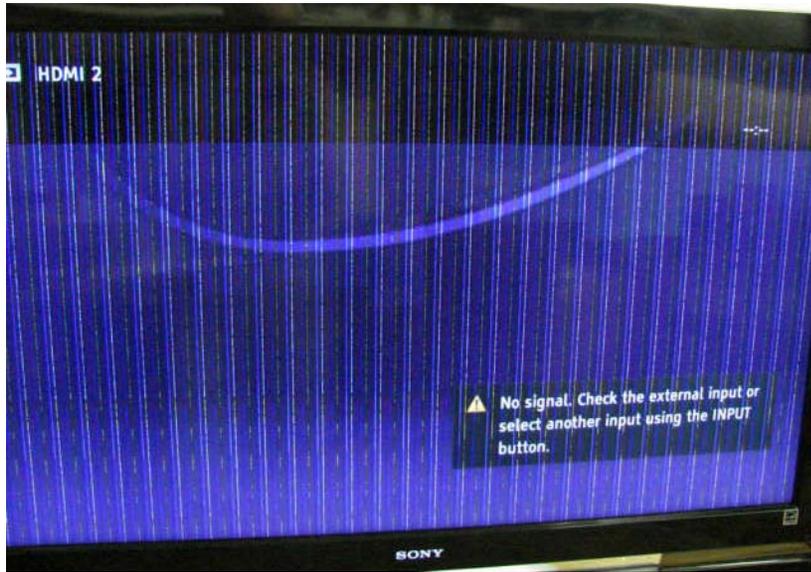
MULTIPLE EVENLY SPACED LINES NOT AFFECTED BY PICTURE ZOOMING

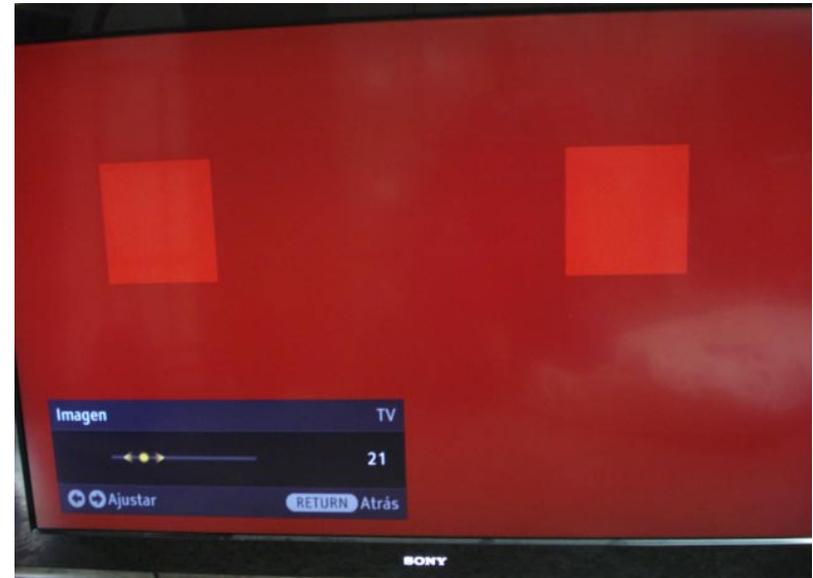
SYMETRICAL RED BOXES

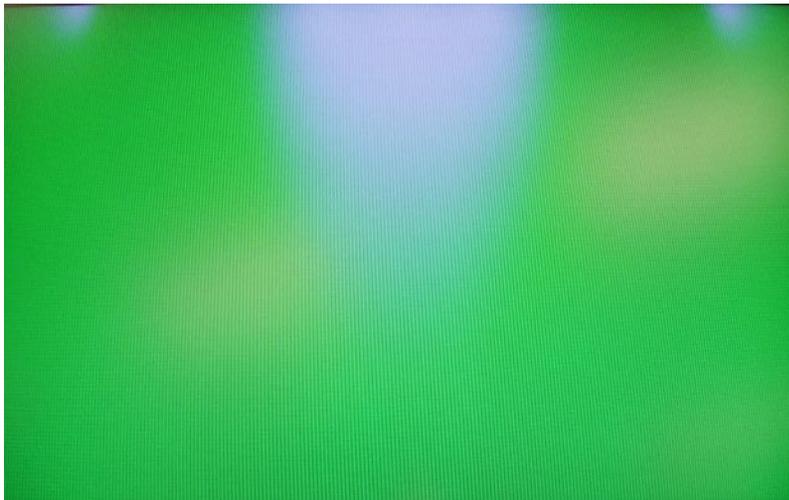
LOADED SOURCE DRIVE DATA LINE

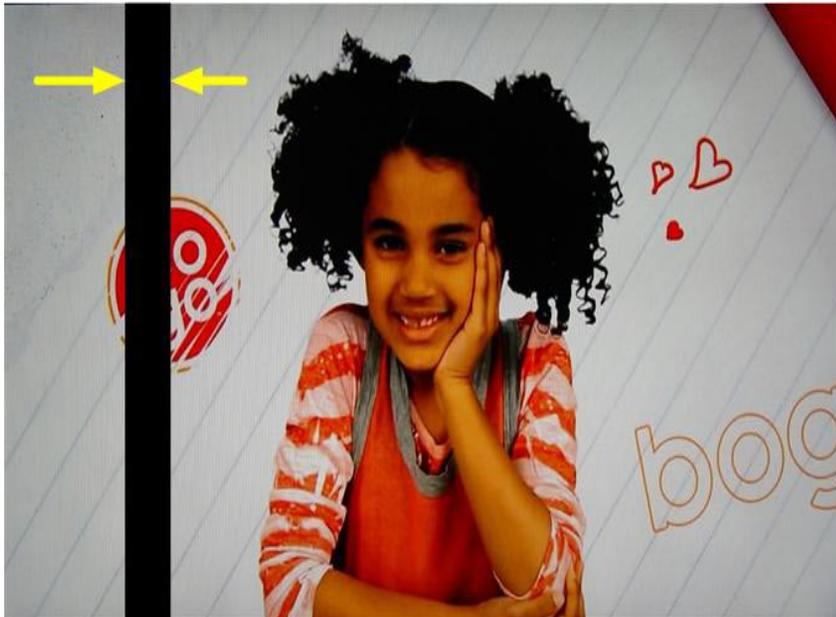
SOURCE DRIVE IC FAILURE

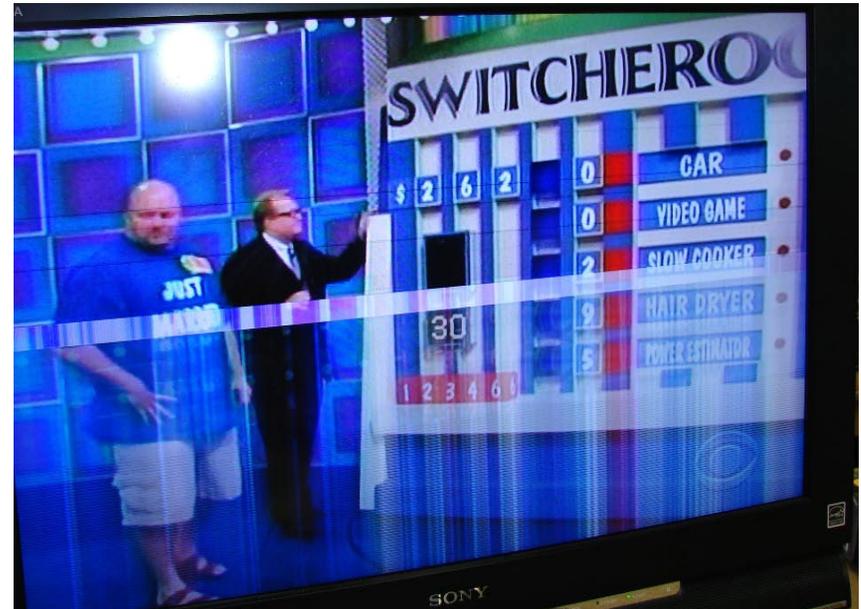
GATE DRIVER FAILURE

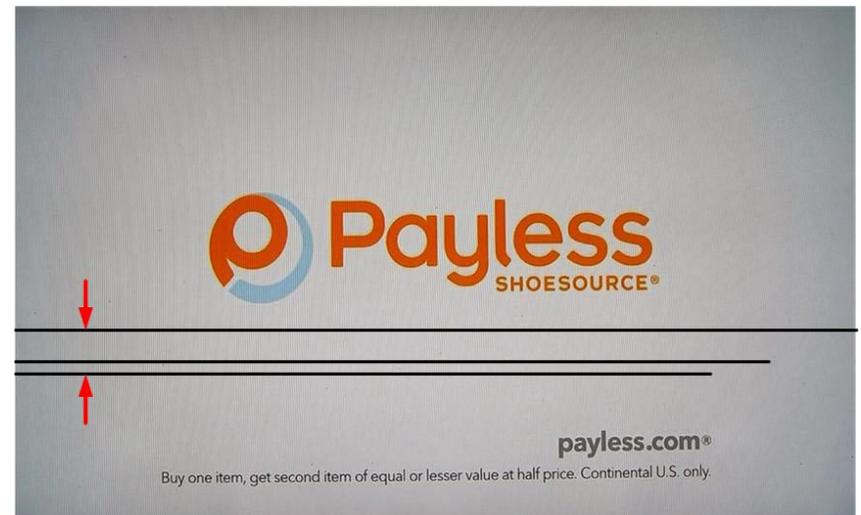
GATE TAB BOND FAILURE

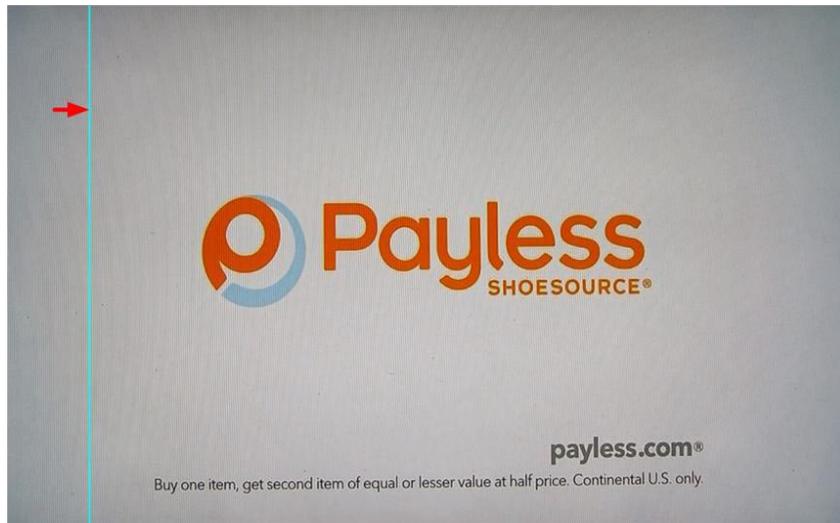
SOURCE TAB BOND FAILURE

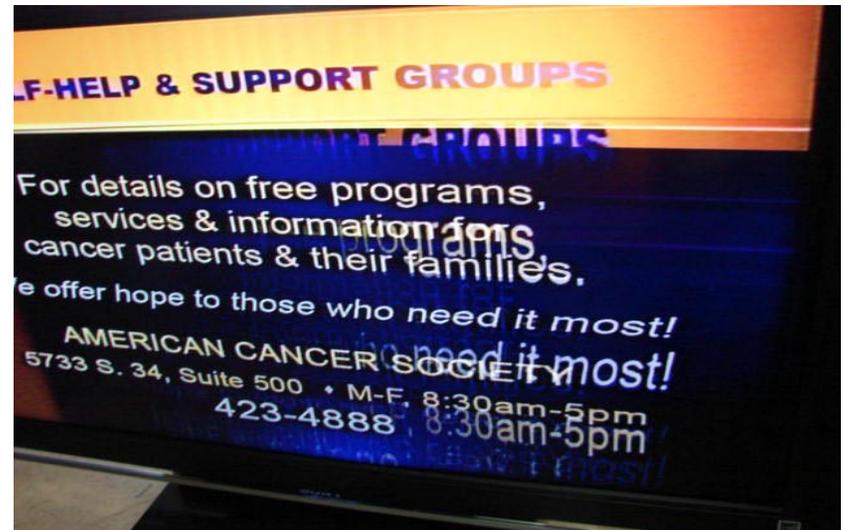
GATE TAB BOND FAILURE

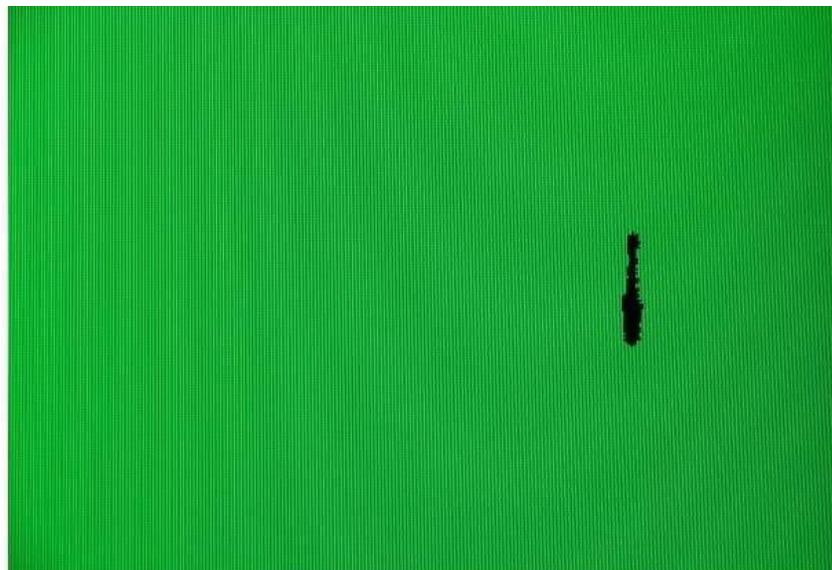
MULTIPLE PIXEL FAILURE

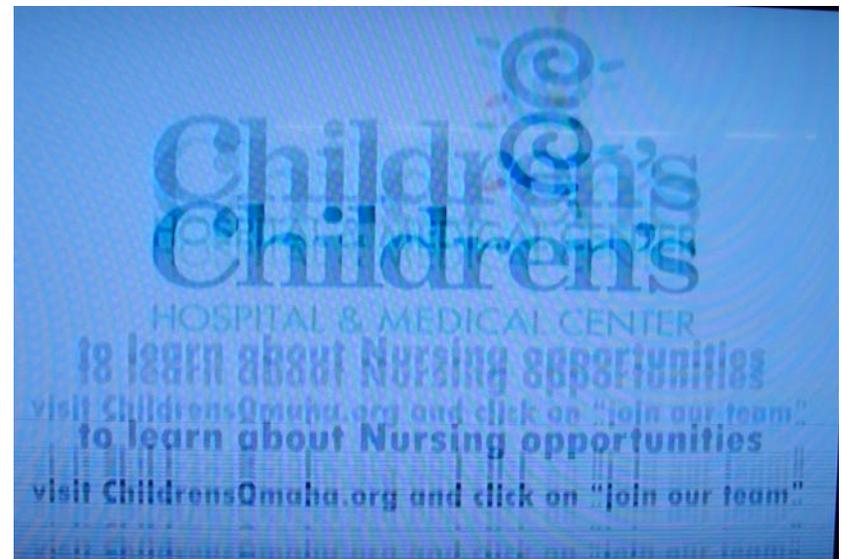
GATE TAB BOND FAILURE
